REPORT OF RCRA COMPLIANCE EVALUATION INSPECTION

Chrome Reflections
4141 East 14th Street
Des Moines, Iowa 50313
(515) 491-8915
EPA ID Number: IAR000521112

April 15, 2019

U.S. ENVIRONMENTAL PROTECTION AGENCY
Region 7
Enforcement & Compliance Assurance Division

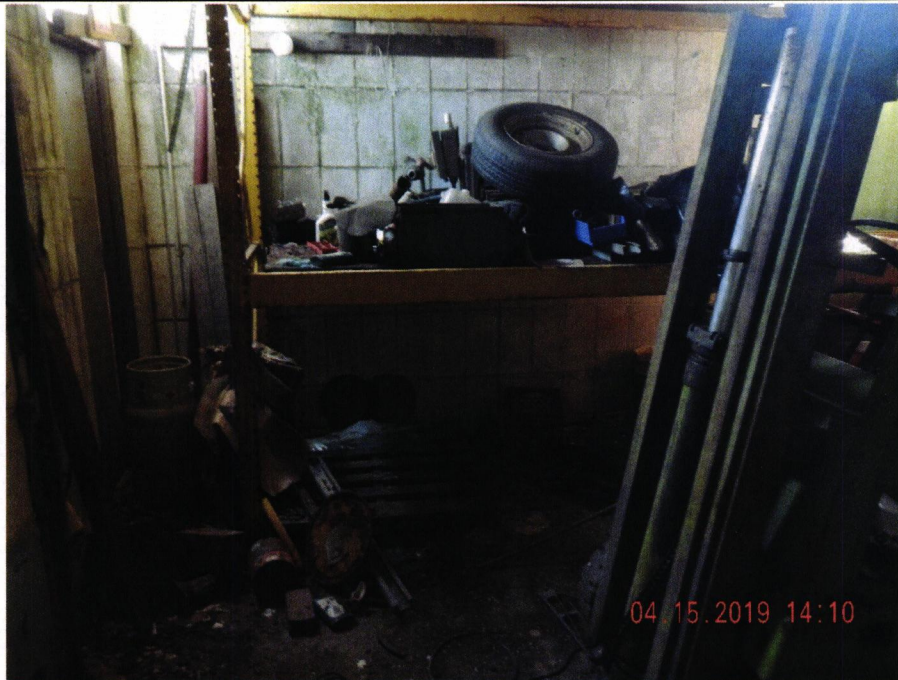
Compliance Evaluation Inspection	DESCRIPTION	Photo of the shelves located in the southeast corner of the facility with trash and debris remaining. The chemicals shown in the September 6, 2016, EPA report (photos 21 - 26) have been removed and disposed.	1
	PHOTOGRAPHER	Trevor Urban	Date <i>TLU</i> 04/15/19

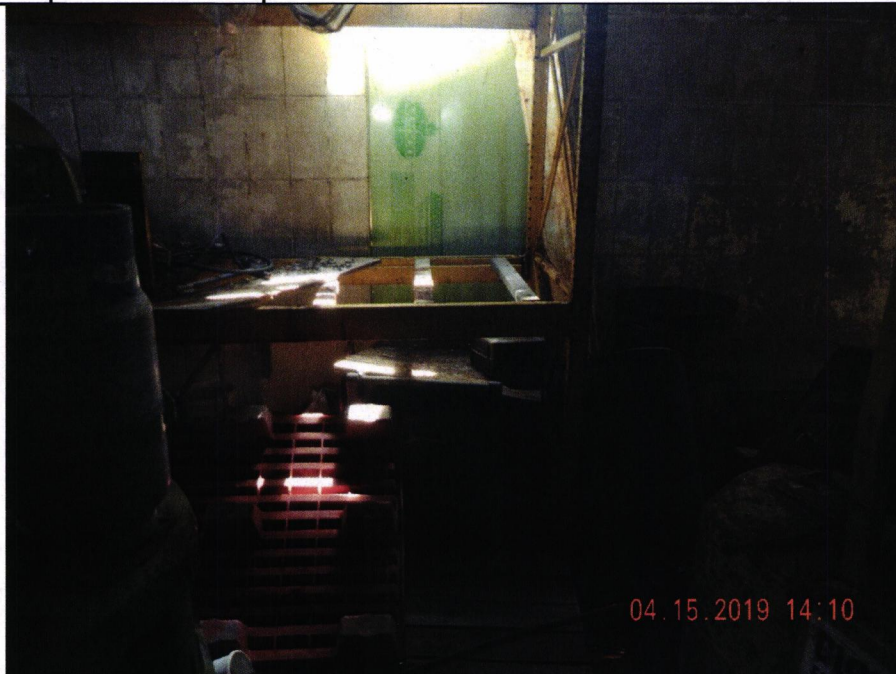
Compliance Evaluation Inspection	DESCRIPTION	Photo of the shelves located in the southeast corner of the facility with trash and debris remaining. The chemicals shown in the Sept. 6, 2016, EPA report (photos 21 - 26) have been removed & disposed except for the two 55-gallon containers on the right.	2
	PHOTOGRAPHER	Trevor Urban	Date <i>TLU</i> 04/15/19

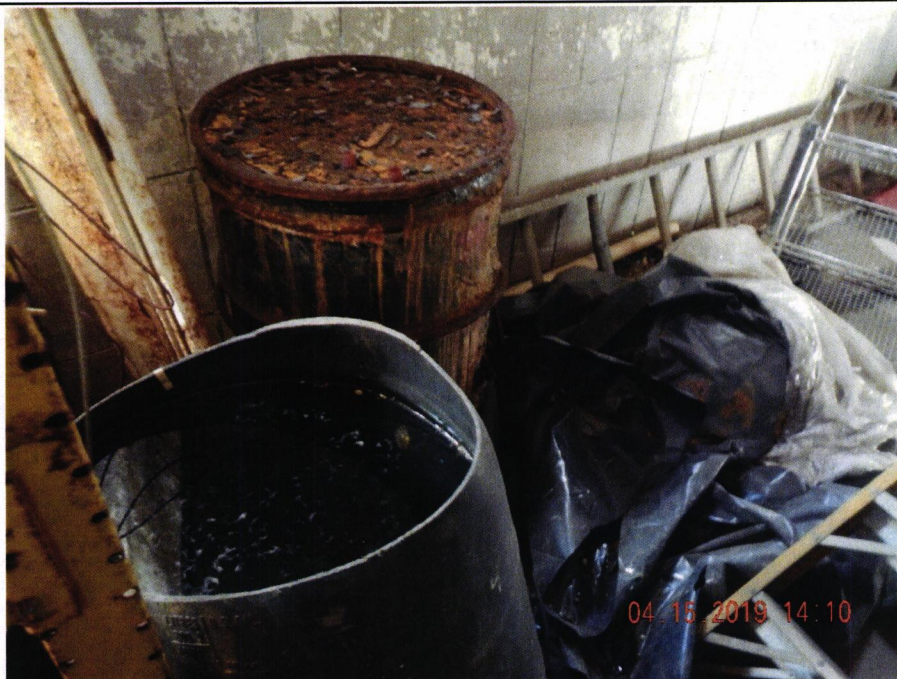
Compliance Evaluation Inspection	DESCRIPTION	Photo of the two 55-gallon containers shown in photo 2. The steel container is closed and very rusty and was identified in the Sept. 6, 2016, EPA report (photo 22). The black plastic container has an open top and the liquid was blue in color.	3
	PHOTOGRAPHER	Trevor Urban	Date <i>TU</i> 04/15/19

South Shelving Unit Remaining Chemicals - I observed a heavily corroded black steel 55-gallon container and an open top plastic 55-gallon container that were identified during the September 9, 2016, EPA inspection and were included on the 2016 NOV for failure to make a waste determination (photos 2 & 3 in attachment 5). The heavily corroded black steel 55-gallon container remains onsite and the conditions appeared to be unchanged since the September 9, 2016, EPA inspection. The open top plastic 55-gallon container was full of a water/chemical mixture and was observed with several inches of liquid in it during the September 9, 2016, EPA inspection (page 3 in attachment 9). Ms. Atkinson stated that the additional liquid in the open top plastic 55-gallon container may be attributed from leaks in the roof of the facility and the recent rain events I informed Ms. Atkinson that a waste determination for both 55-gallon containers must be performed to ensure proper disposal (attachment 9).

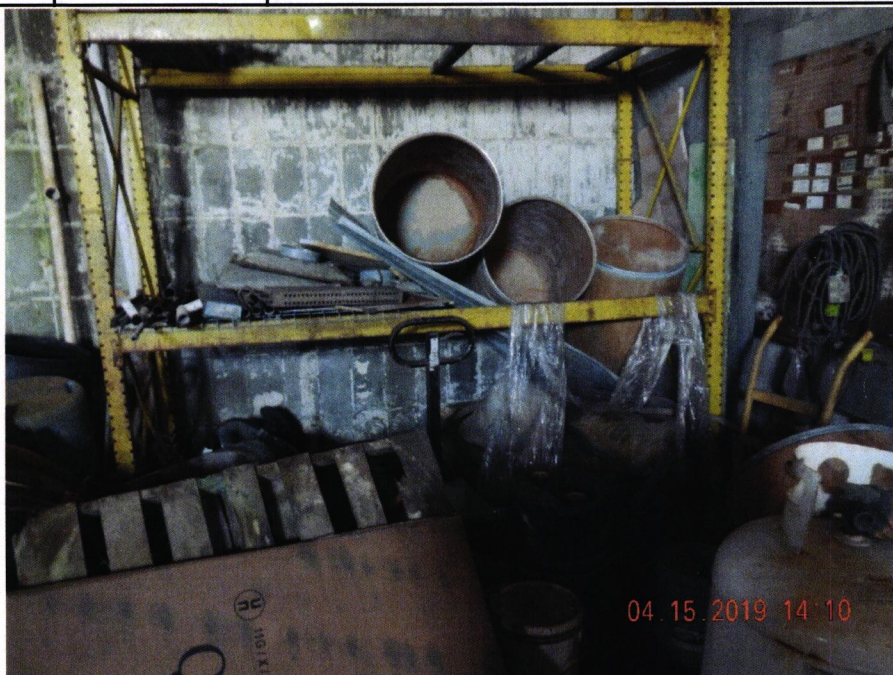
Compliance Evaluation Inspection	DESCRIPTION	Photo of the shelves located in the northeast corner of the facility with trash and debris remaining. The chemicals shown in the Sept. 6, 2016, EPA report (photo 20) have been removed and disposed except for the 12 bags of sodium hypochlorite.	4
	PHOTOGRAPHER	Trevor Urban	Date <i>TU</i> 04/15/19

North Shelving Unit Remaining Chemicals - I observed approximately 12 bags (paper bags weighing approximately 40 lbs – 50 lbs each) labeled as sodium hypochlorite that were identified during the September 9, 2016, EPA inspection and were included on the 2016 NOV for failure to make a waste determination (photo 20 in attachment 7 and photo 4 in attachment 5). The bags remain onsite and the conditions appeared to be unchanged since the September 9, 2016, EPA inspection. I also observed six plastic containers on the floor that were previously shown on the top shelf of the north shelving unit that were identified during the September 9, 2016, EPA

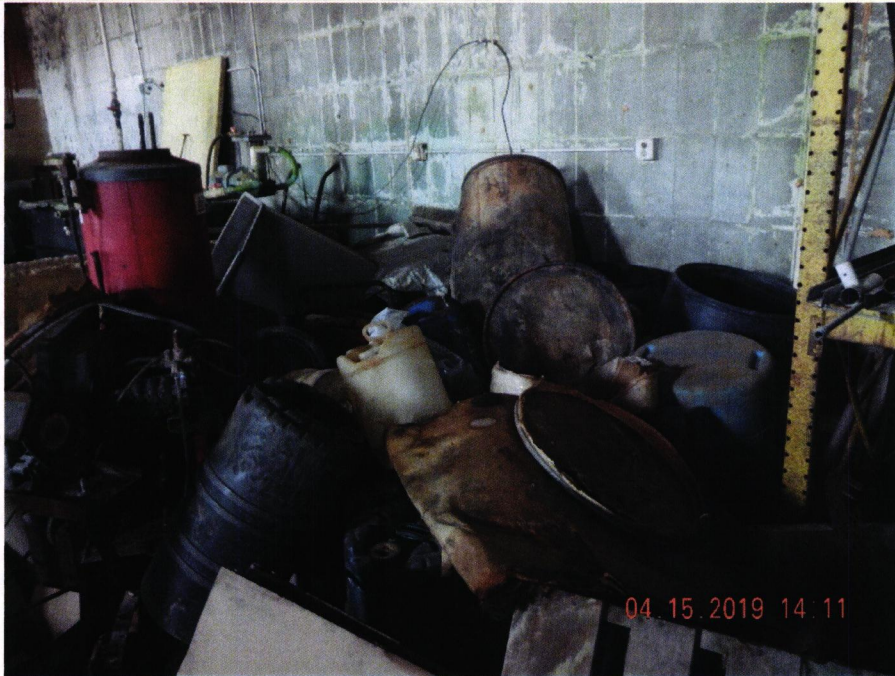
Compliance Evaluation Inspection	DESCRIPTION	Photo of trash/debris and empty containers along the north wall of the building directly west of the northeast shelves. The four plastic barrel line with lead anodes shown in the Sept. 6, 2016, EPA report (photo 17) have been removed and disposed.	5
	PHOTOGRAPHER	Trevor Urban	Date <i>TU</i> 04/15/19

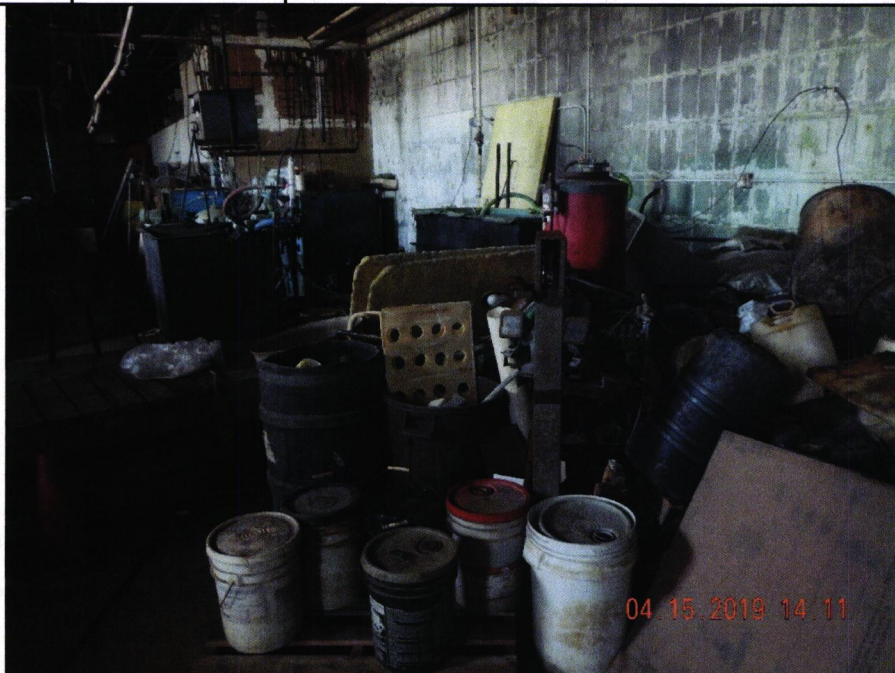
Compliance Evaluation Inspection	DESCRIPTION	Photo of six 5-gallon plastic containers on the floor that were previously shown on the northeast top shelf in the Sept. 6, 2016, EPA report (photo 20). The containers appeared to hold oil lubricants. Two plating tanks are shown in the background.	6
	PHOTOGRAPHER	Trevor Urban	Date <i>TU</i> 04/15/19

inspection and were included on the 2016 NOV for failure to make a waste determination (photo 20 in attachment 7 and photo 6 in attachment 5). The six plastic containers appeared to contain oil lubricants and remain onsite. Their conditions appeared to be unchanged since the September 9, 2016, EPA inspection. I informed Ms. Atkinson that a waste determination must be performed for the bags and plastic containers to ensure proper disposal (attachment 9).

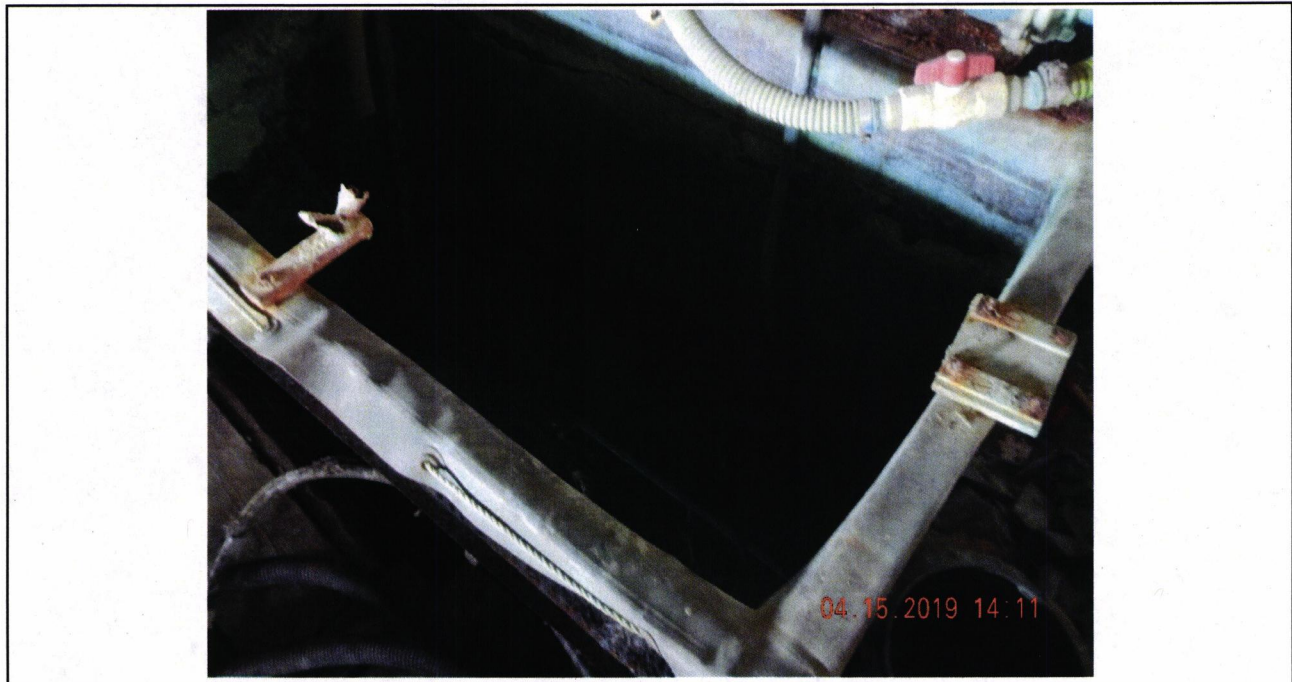
Compliance Evaluation Inspection	DESCRIPTION	Photo of the single plating tank located near the north wall of the facility that is empty but still holds less than an inch of blue liquid in the bottom. The plating tank was full of liquid with lead anodes in the Sept. 6, 2016, EPA report (photo 14).	7
	PHOTOGRAPHER	Trevor Urban	Date <i>TLU</i> 04/15/19

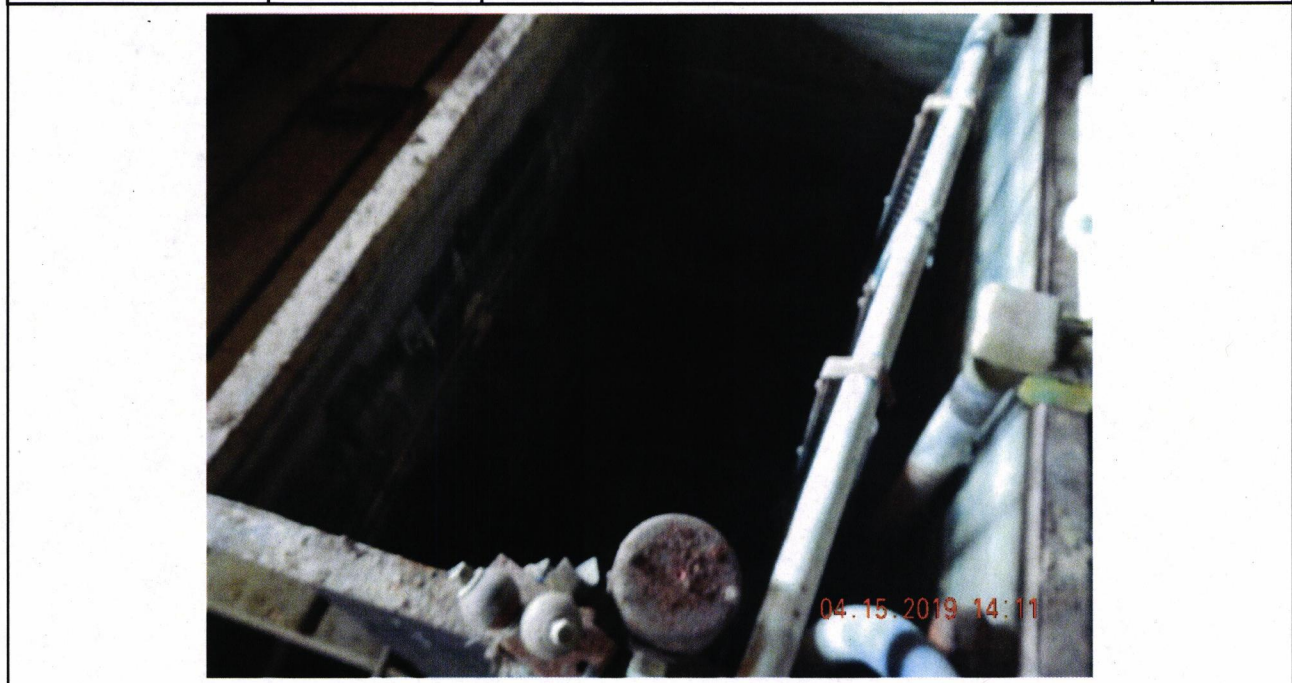
Compliance Evaluation Inspection	DESCRIPTION	Photo of the single plating tank located directly north of the main plating line that is empty but still holds less than an inch of blue liquid in the bottom. The plating tank was full of liquid with lead anodes in the Sept. 6, 2016, EPA report (photo 13).	8
	PHOTOGRAPHER	Trevor Urban	Date <i>TLU</i> 04/15/19

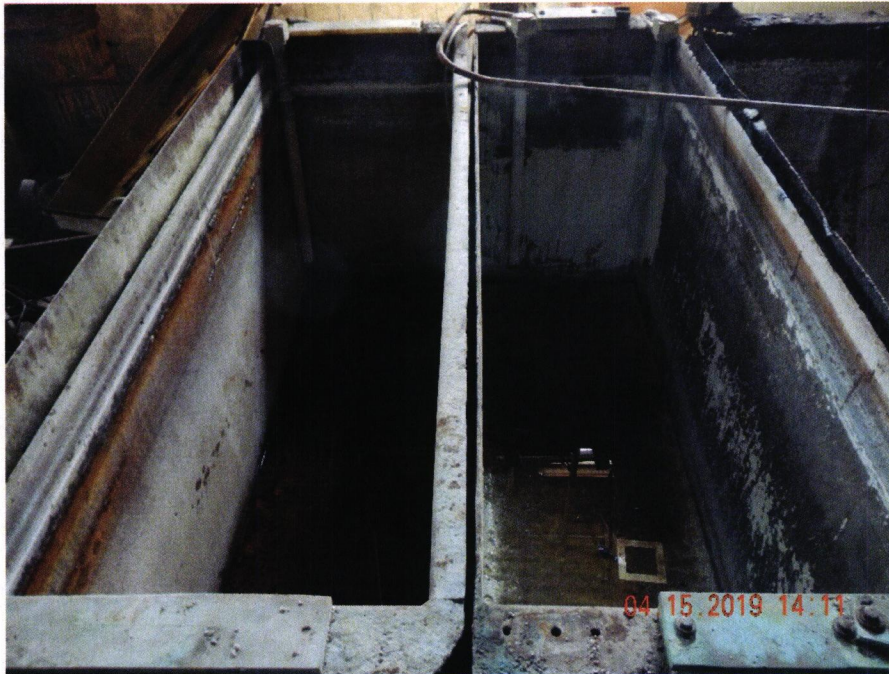
Compliance Evaluation Inspection	DESCRIPTION	Photo of two plating tanks located on the east end of the main plating line that were identified as tanks 13 & 12 when sampled by Seneca. The two tanks are now empty but still hold several inches of clear liquid with red solids in the bottom.	9
	PHOTOGRAPHER	Trevor Urban	Date <i>TU</i> 04/15/19

Sludge and Liquids in Empty Tanks 1 - 13 – I observed the 13 plating tanks located along the south wall of the facility (photos 9 – 18 and attachment 6). I also observed two additional plating tanks located directly north of tank 12 and near the north wall of the of the plating area (photos 7, 8, 19 & 20 and attachment 6). The liquids were being removed from the plating tanks during the

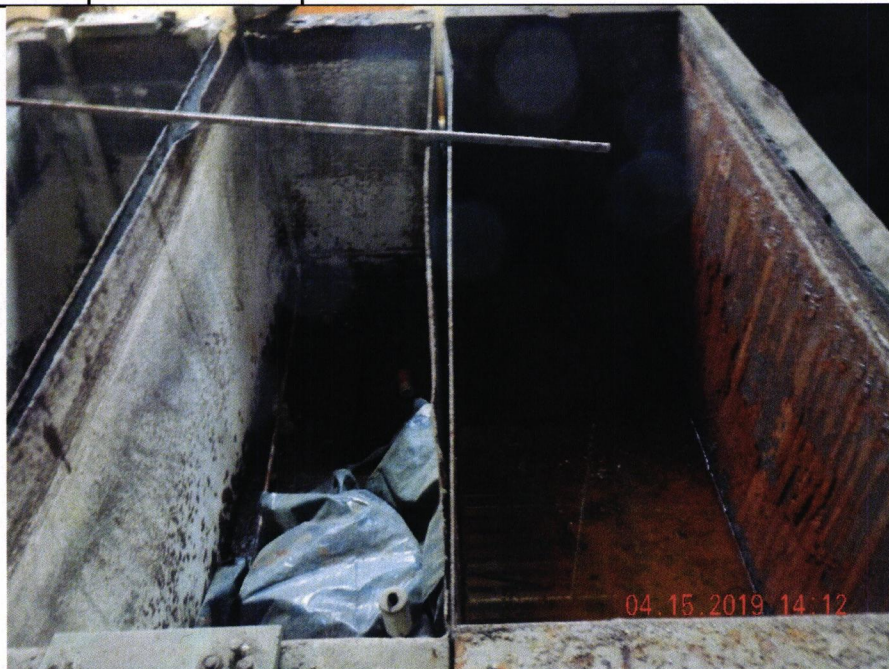
Compliance Evaluation Inspection	DESCRIPTION	Photo of two plating tanks located in the main plating line that were identified as an empty tank & tank 11 when sampled by Seneca. Tank 11 is now also empty but still holds several inches of clear liquid with red solids in the bottom.	10
	PHOTOGRAPHER	Trevor Urban	Date <i>TU</i> 04/15/19

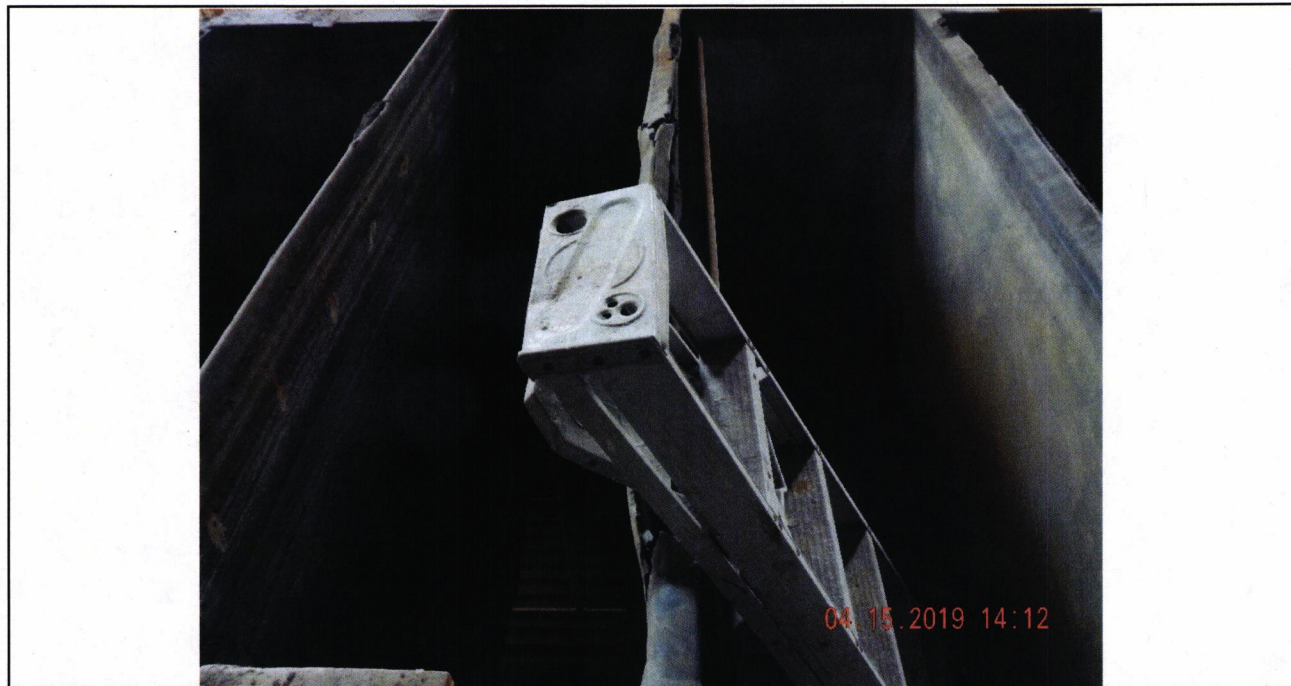
Compliance Evaluation Inspection	DESCRIPTION	Photo of two plating tanks located in the main plating line (photo 12 in the Sept. 6, 2016, EPA report) and identified as tanks 10 & 9 when sampled by Seneca. The two tanks are now empty but still hold several inches of clear liquid with solids in the bottom.	11
	PHOTOGRAPHER	Trevor Urban	Date TLU 04/15/19

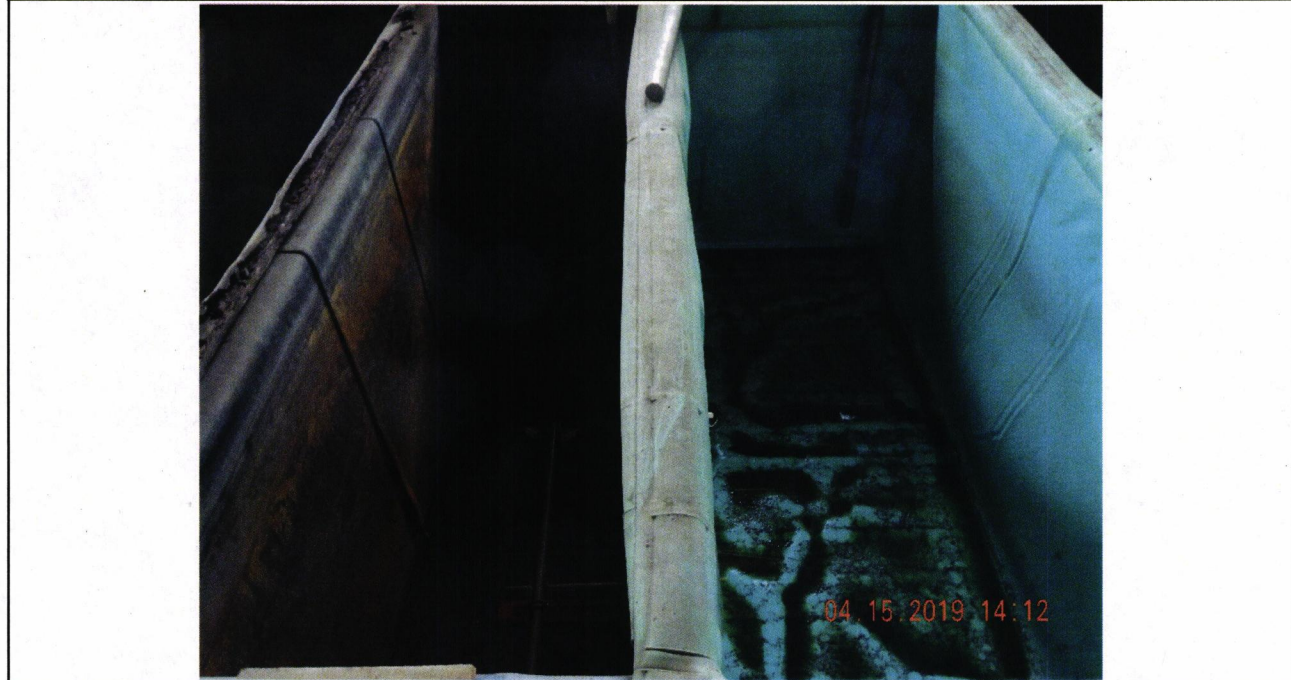
Compliance Evaluation Inspection	DESCRIPTION	Photo of two plating tanks located in main plating line (photos 12 & 16 in the Sept. 6, 2016, EPA report) & identified as tanks 8 & 7 when sampled by Seneca. The two tanks are now empty but still hold several inches of clear liquid with solids in the bottom.	12
	PHOTOGRAPHER	Trevor Urban	Date TLU 04/15/19

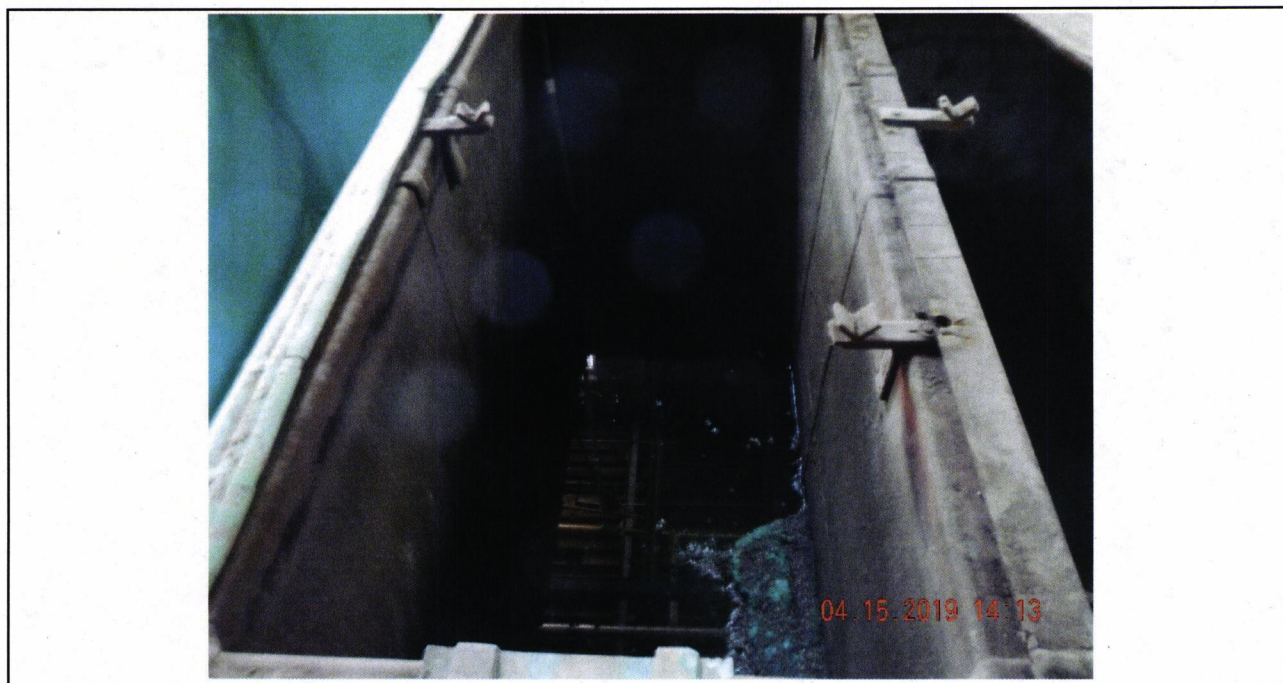
Compliance Evaluation Inspection	DESCRIPTION	Photo of a single plating tank located in the main plating line that was identified as empty during sampling by Seneca (photo 11 in the Sept. 6, 2016, EPA report). The tank is still empty but holds less than an inch of liquid with blue solids in the bottom.	13
	PHOTOGRAPHER		Date <i>TU</i> 04/15/19

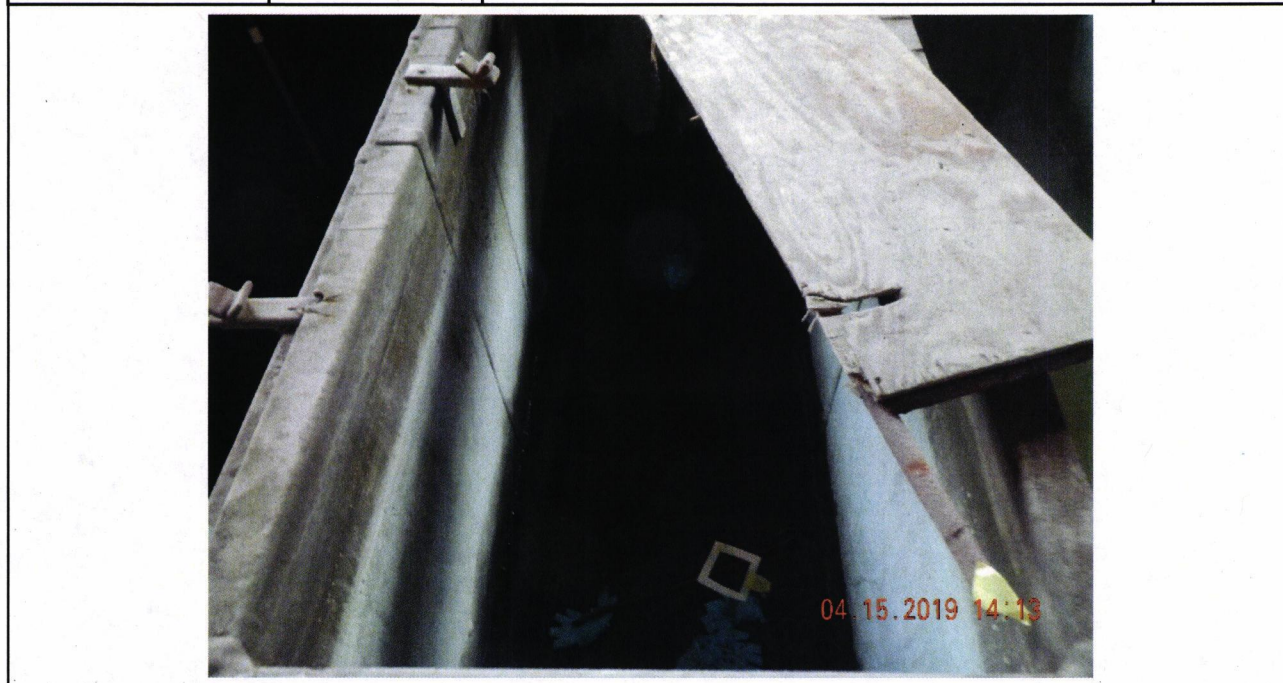
Compliance Evaluation Inspection	DESCRIPTION	Photo of a single plating tank located in the main plating line that was identified as tank 6 when sampled by Seneca. The tank is now empty but still holds several inches of clear liquid.	14
	PHOTOGRAPHER		Date <i>TU</i> 04/15/19

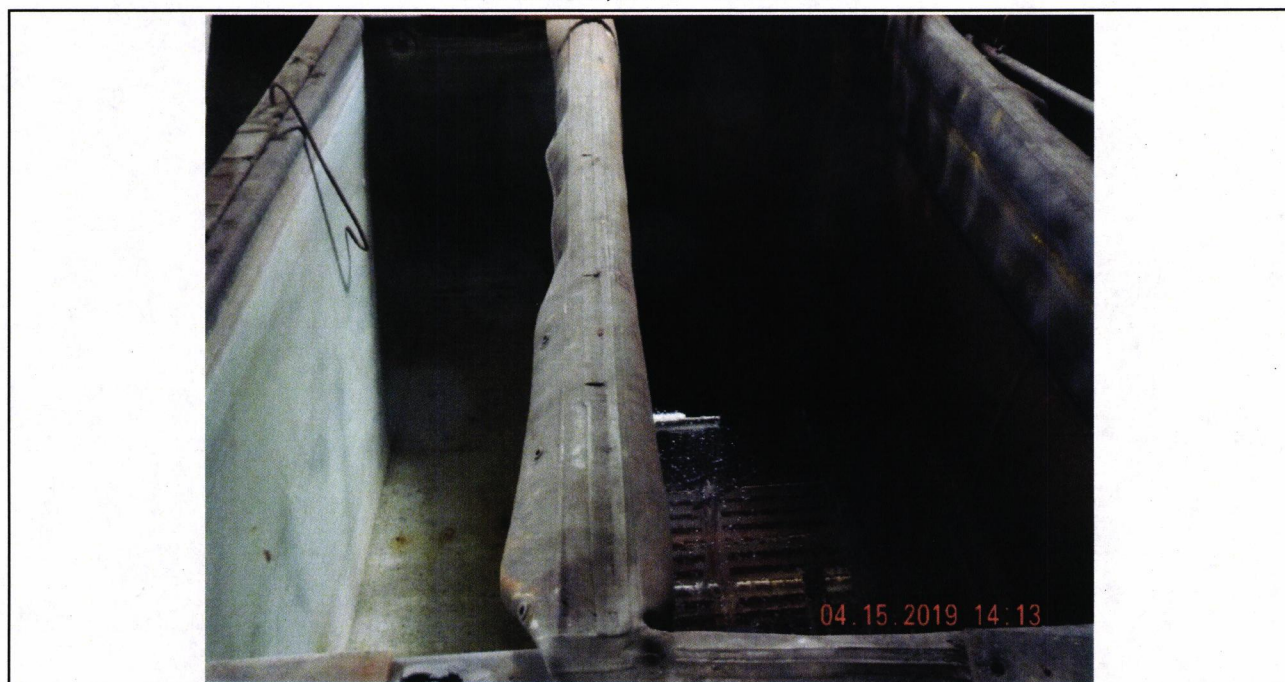
Compliance Evaluation Inspection	DESCRIPTION	Photo of two plating tanks located in main plating line (photos 10 & 15 in the Sept. 6, 2016, EPA report) & identified as tanks 4 & 5 when sampled by Seneca. The two tanks are now empty but still hold several inches of clear liquid with solids in the bottom.	15
	PHOTOGRAPHER	Trevor Urban	Date TLU 04/15/19

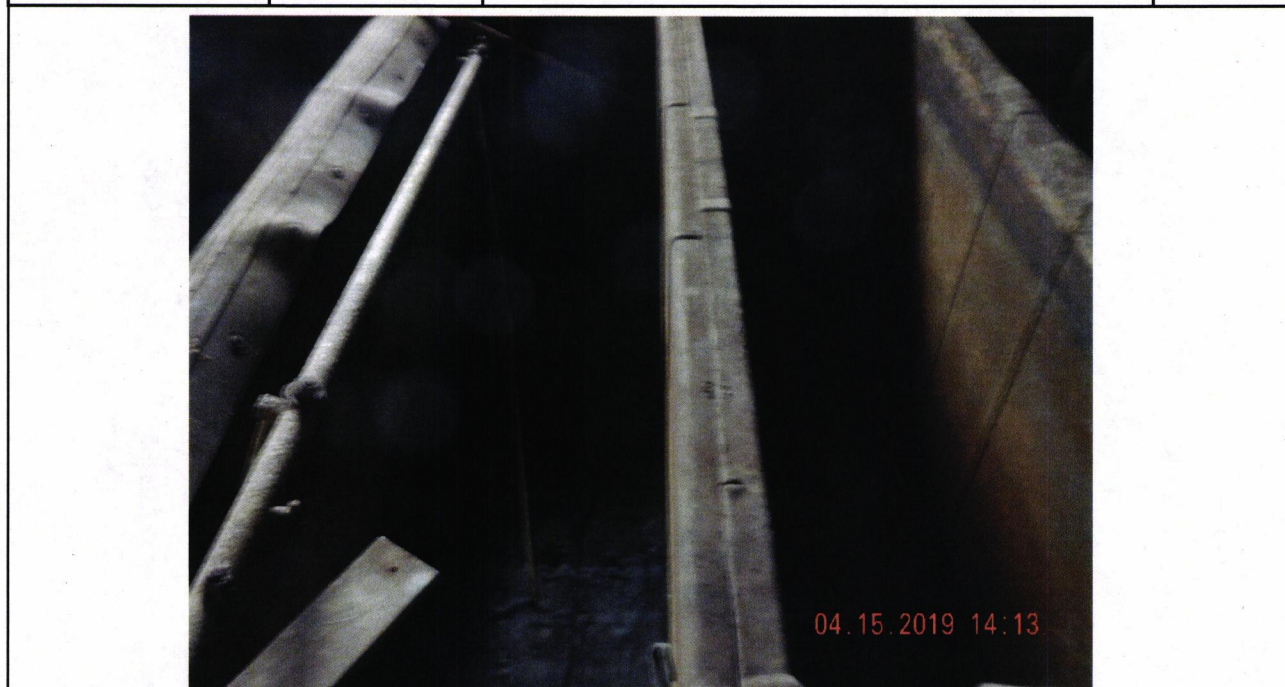
Compliance Evaluation Inspection	DESCRIPTION	Photo of two plating tanks located in main plating line identified as tanks 2 & 3 when sampled by Seneca. The two tanks are now empty but still hold less than an inch of clear liquid with solids in the bottom.	16
	PHOTOGRAPHER	Trevor Urban	Date TLU 04/15/19

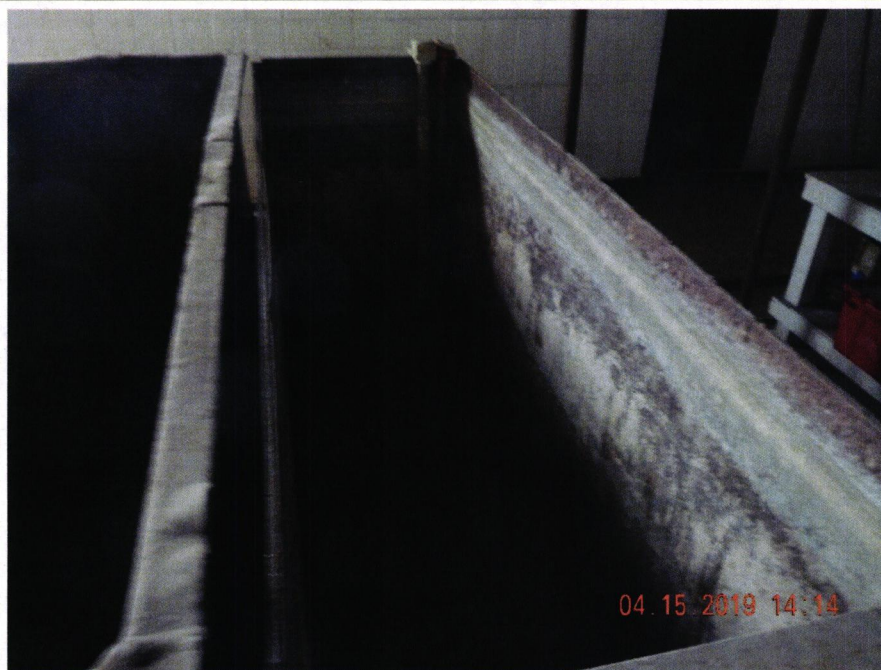
Compliance Evaluation Inspection	DESCRIPTION	Photo of a single plating tank located on the west end of the main plating line that was identified as tank 1 when sampled by Seneca (photo 1 in the Sept. 6, 2016, EPA report). The tank is now empty but still holds less than an inch of clear liquid.	17
	PHOTOGRAPHER	Trevor Urban	Date T.U. 04/15/19

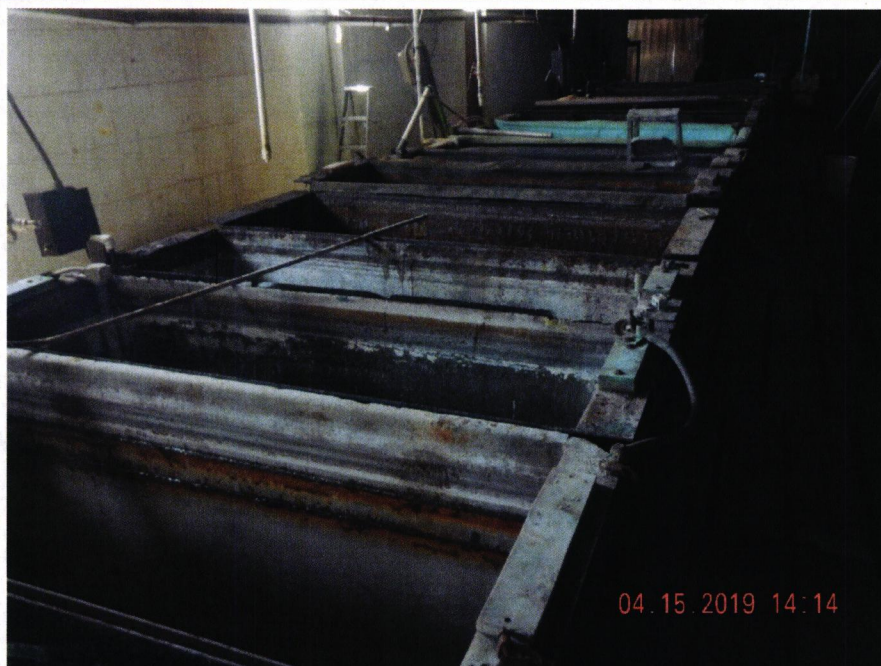
Compliance Evaluation Inspection	DESCRIPTION	Photo of the main plating line located along the south wall of the plating room and a wooden walkway along the north side of the plating line. The tanks are all mostly empty with only several inches or less of liquid and solids remaining in them.	18
	PHOTOGRAPHER	Trevor Urban	Date T.U. 04/15/19

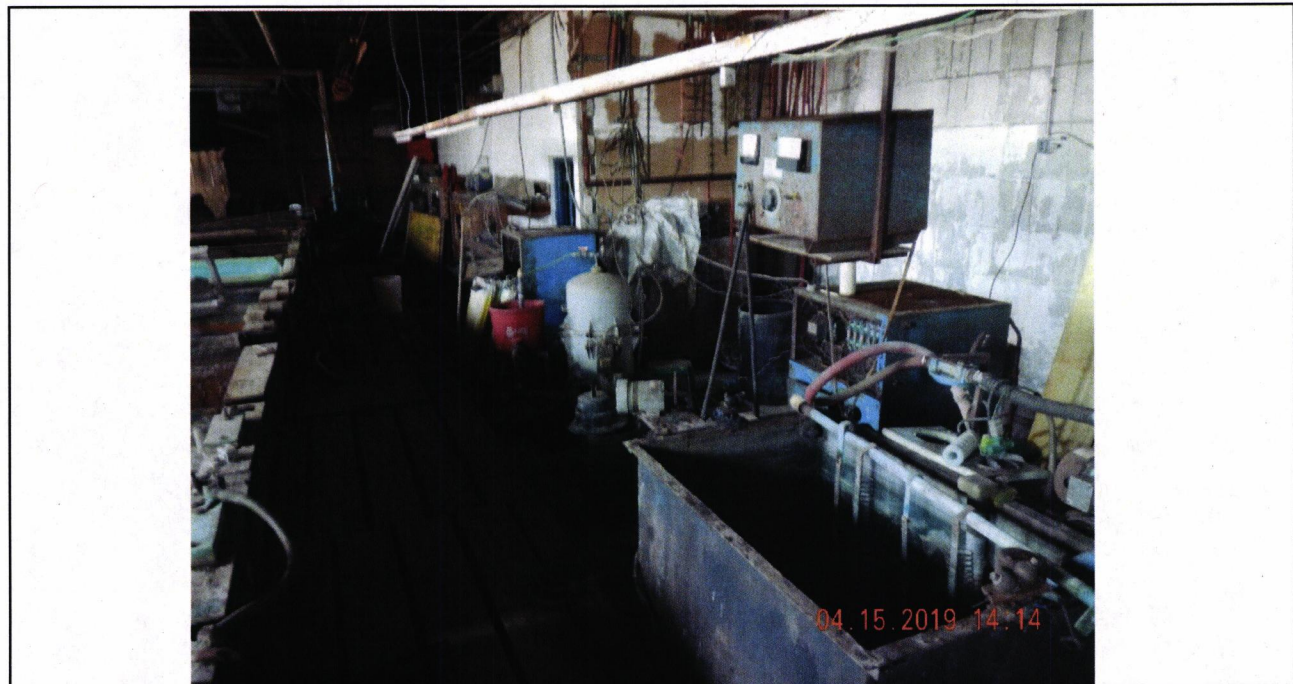
Compliance Evaluation Inspection	DESCRIPTION	Photo of the single plating tank shown in photo 8 directly north of the main plating line. Also shown is the area directly north of the wooden walkway including the reactor tank which was identified in the Sept. 6, 2016, EPA report (photos 5 & 6).	19
	PHOTOGRAPHER	Trevor Urban	Date TLU. 04/15/19

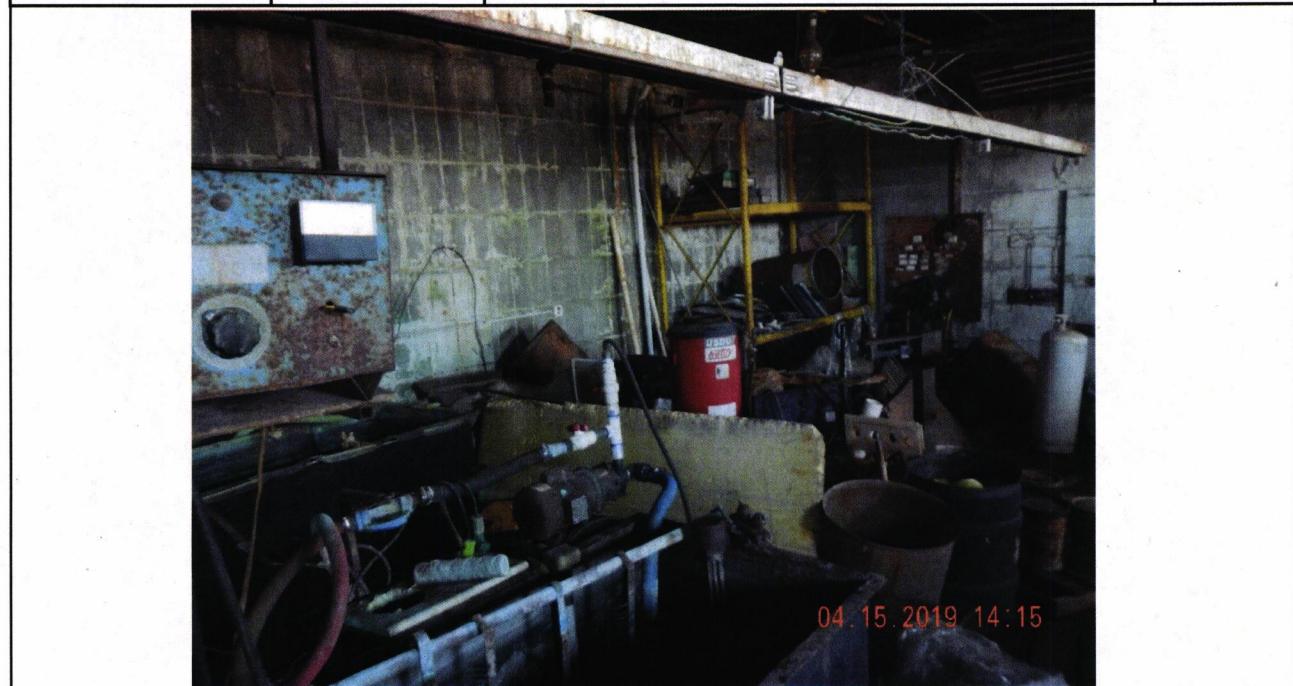
Compliance Evaluation Inspection	DESCRIPTION	Photo of the two single plating tanks located directly north of the main plating line that are now empty but still holds less than an inch of blue liquid in the bottom. Also shown is the trash/debris and empty containers directly west of the northeast shelves.	20
	PHOTOGRAPHER	Trevor Urban	Date TLU. 04/15/19

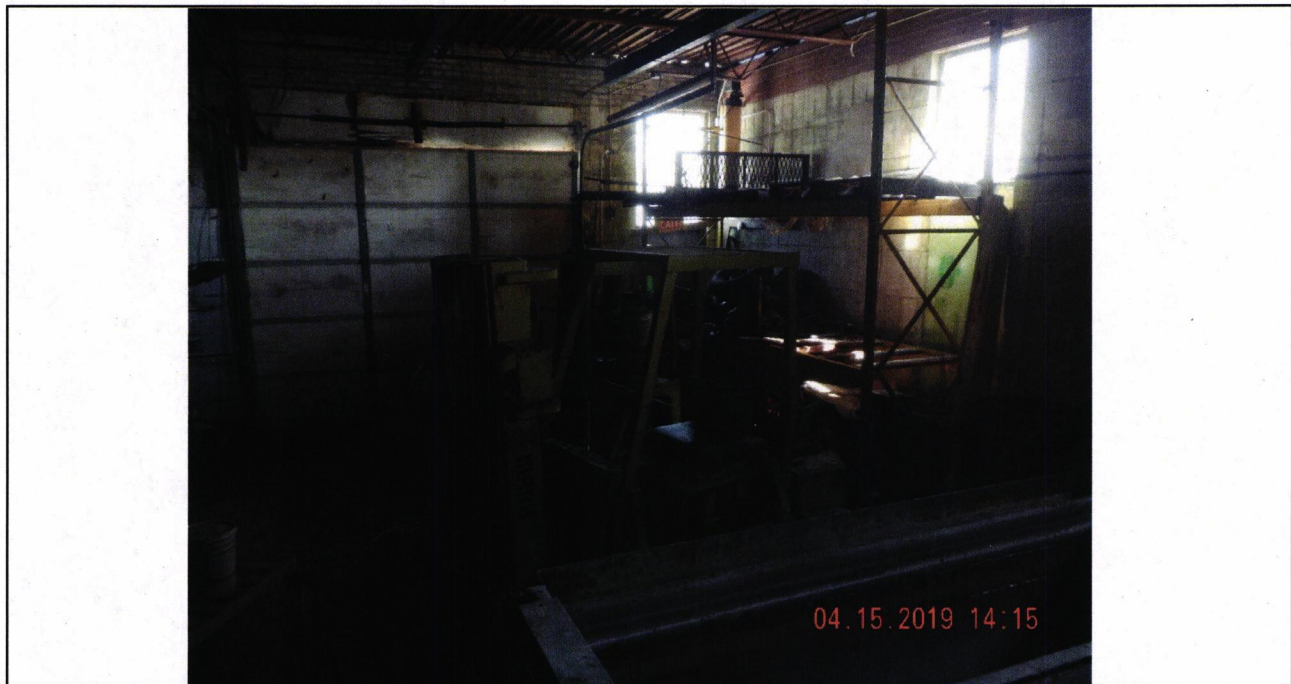
Compliance Evaluation Inspection	DESCRIPTION	Photo of the shelves located in the southeast corner of the facility with trash and debris remaining. The chemicals shown in the Sept. 6, 2016, EPA report (photos 21 - 26) have been removed and disposed except for the two containers on the right.	21
	PHOTOGRAPHER		Date <i>TLU.</i> 04/15/19
Direction: Southeast		Trevor Urban

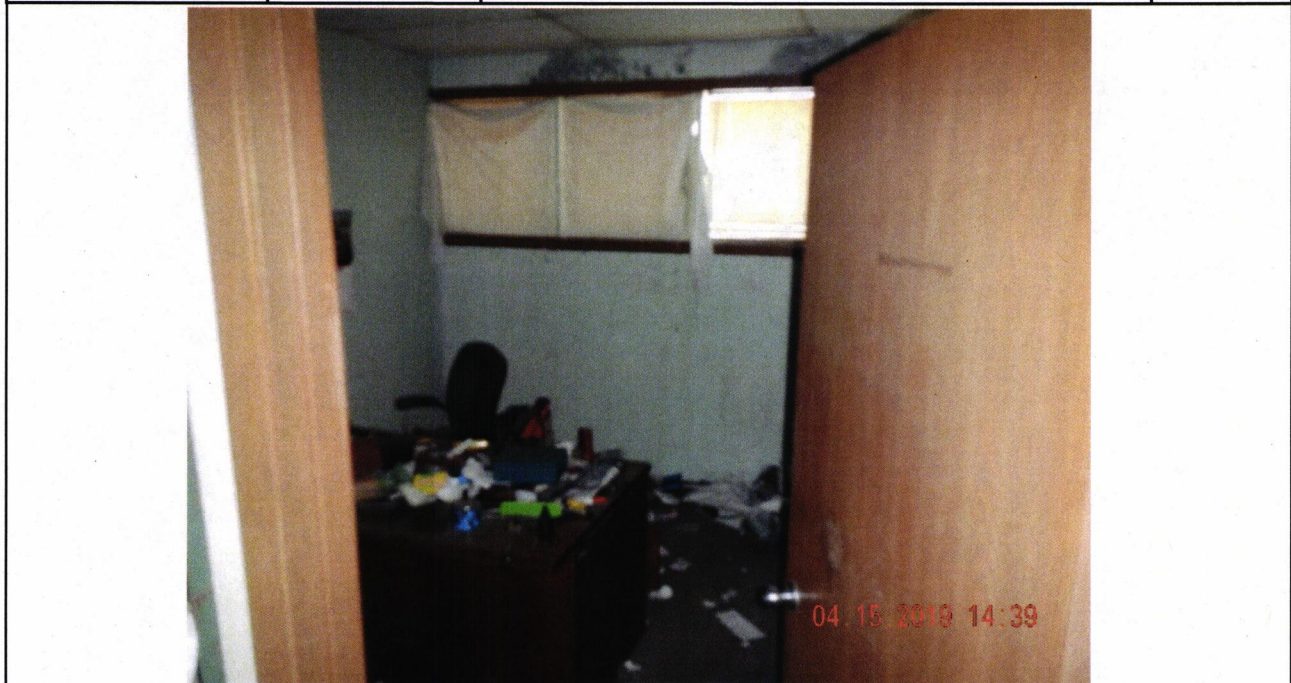
Compliance Evaluation Inspection	DESCRIPTION	Photo of the facility office located along the north wall of the facility directly west of the maintenance/tool area. The door to the office was locked during the Sept. 6, 2016, EPA inspection.	22
	PHOTOGRAPHER		Date <i>TLU.</i> 04/15/19
Direction: Northwest		Trevor Urban

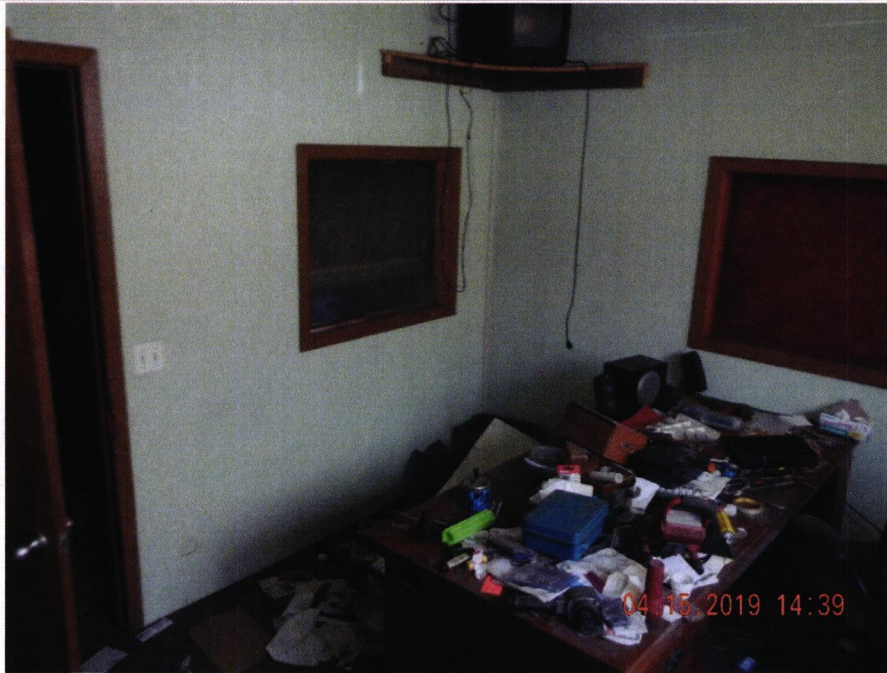
Compliance Evaluation Inspection	DESCRIPTION	Photo of the facility office located along the north wall of the facility directly west of the maintenance/tool area. The door to the office was locked during the Sept. 6, 2016, EPA inspection.	23
	PHOTOGRAPHER	Trevor Urban	Date <i>TUE</i> 04/15/19
<div style="height: 300px; border: 1px solid black;"></div>			
Compliance Evaluation Inspection	DESCRIPTION		Date
	PHOTOGRAPHER

The facility office was locked and not accessible during the September 9, 2016, EPA inspection and was not visually observed. The facility office was unlocked and accessible during the April 15, 2019, EPA inspection and I observed no wastes (photos 22 & 23 in attachment 5). The facility was not in operation and no contingency plan, training plan, or hazardous waste manifests were available for review.

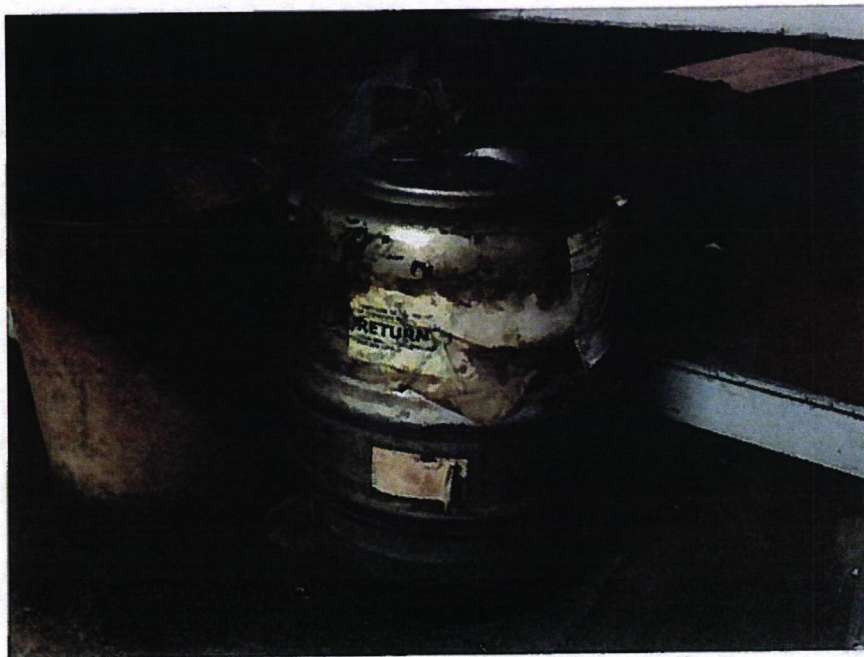
Photo 1 – 9/6/2016, 15-gallon stainless steel container located west of the Main Plating Line.

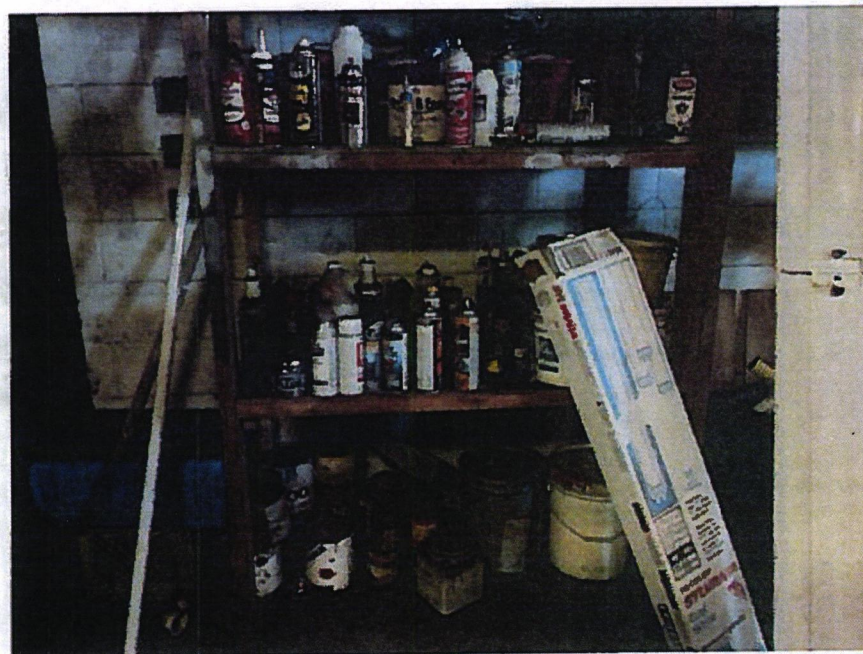
Photo 2 – 9/6/2016. Shelves of cleaners, paints, and other containers along the facility's northern wall.

Shelves of Cleaners Paints and Chemicals/North Wall – I observed approximately 60 containers (aerosol lubricants, paint, cleaners and other containers) located on the wall of the north storage rooms directly northwest of plating tank 1 that were identified during the September 9, 2016, EPA inspection and were included on the 2016 NOV for failure to make a waste determination (photo 2 in attachment 7). The aerosol lubricants, paint, cleaners and other containers remain onsite and the conditions appeared to be unchanged since the September 9, 2016, EPA inspection. I informed Ms. Atkinson that a waste determination must be performed if they could not be used as originally intended to ensure proper disposal (attachment 9).

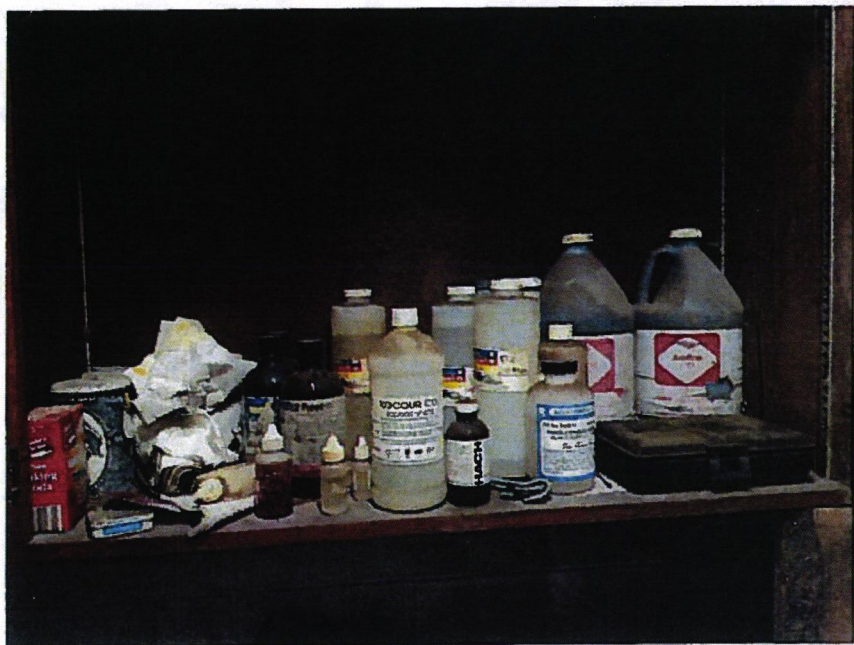
Photo 3 – 9/6/2016. Chemicals located in the north storage rooms.

Chemicals in North Storage Rooms - I observed approximately 25 containers of chemicals in two cabinets located in the north storage room that may have been used as part the conditioning/treatment system for make-up water for the plating operation that were identified during the September 9, 2016, EPA inspection and included on the 2016 NOV for failure to make a waste determination (photos 3 & 4 in attachment 7). The chemicals remain onsite and the conditions appeared to be unchanged since the September 9, 2016, EPA inspection. I informed Ms. Atkinson that a waste determination must be performed to ensure proper disposal (attachment 9).
